**NORTH AREA SOIL
SAMPLE LOCATIONS**

FINAL BASELINE ECOLOGICAL RISK ASSESSMENT

GULFCO MARINE MAINTENANCE
FREEPORT, BRAZORIA COUNTY, TEXAS

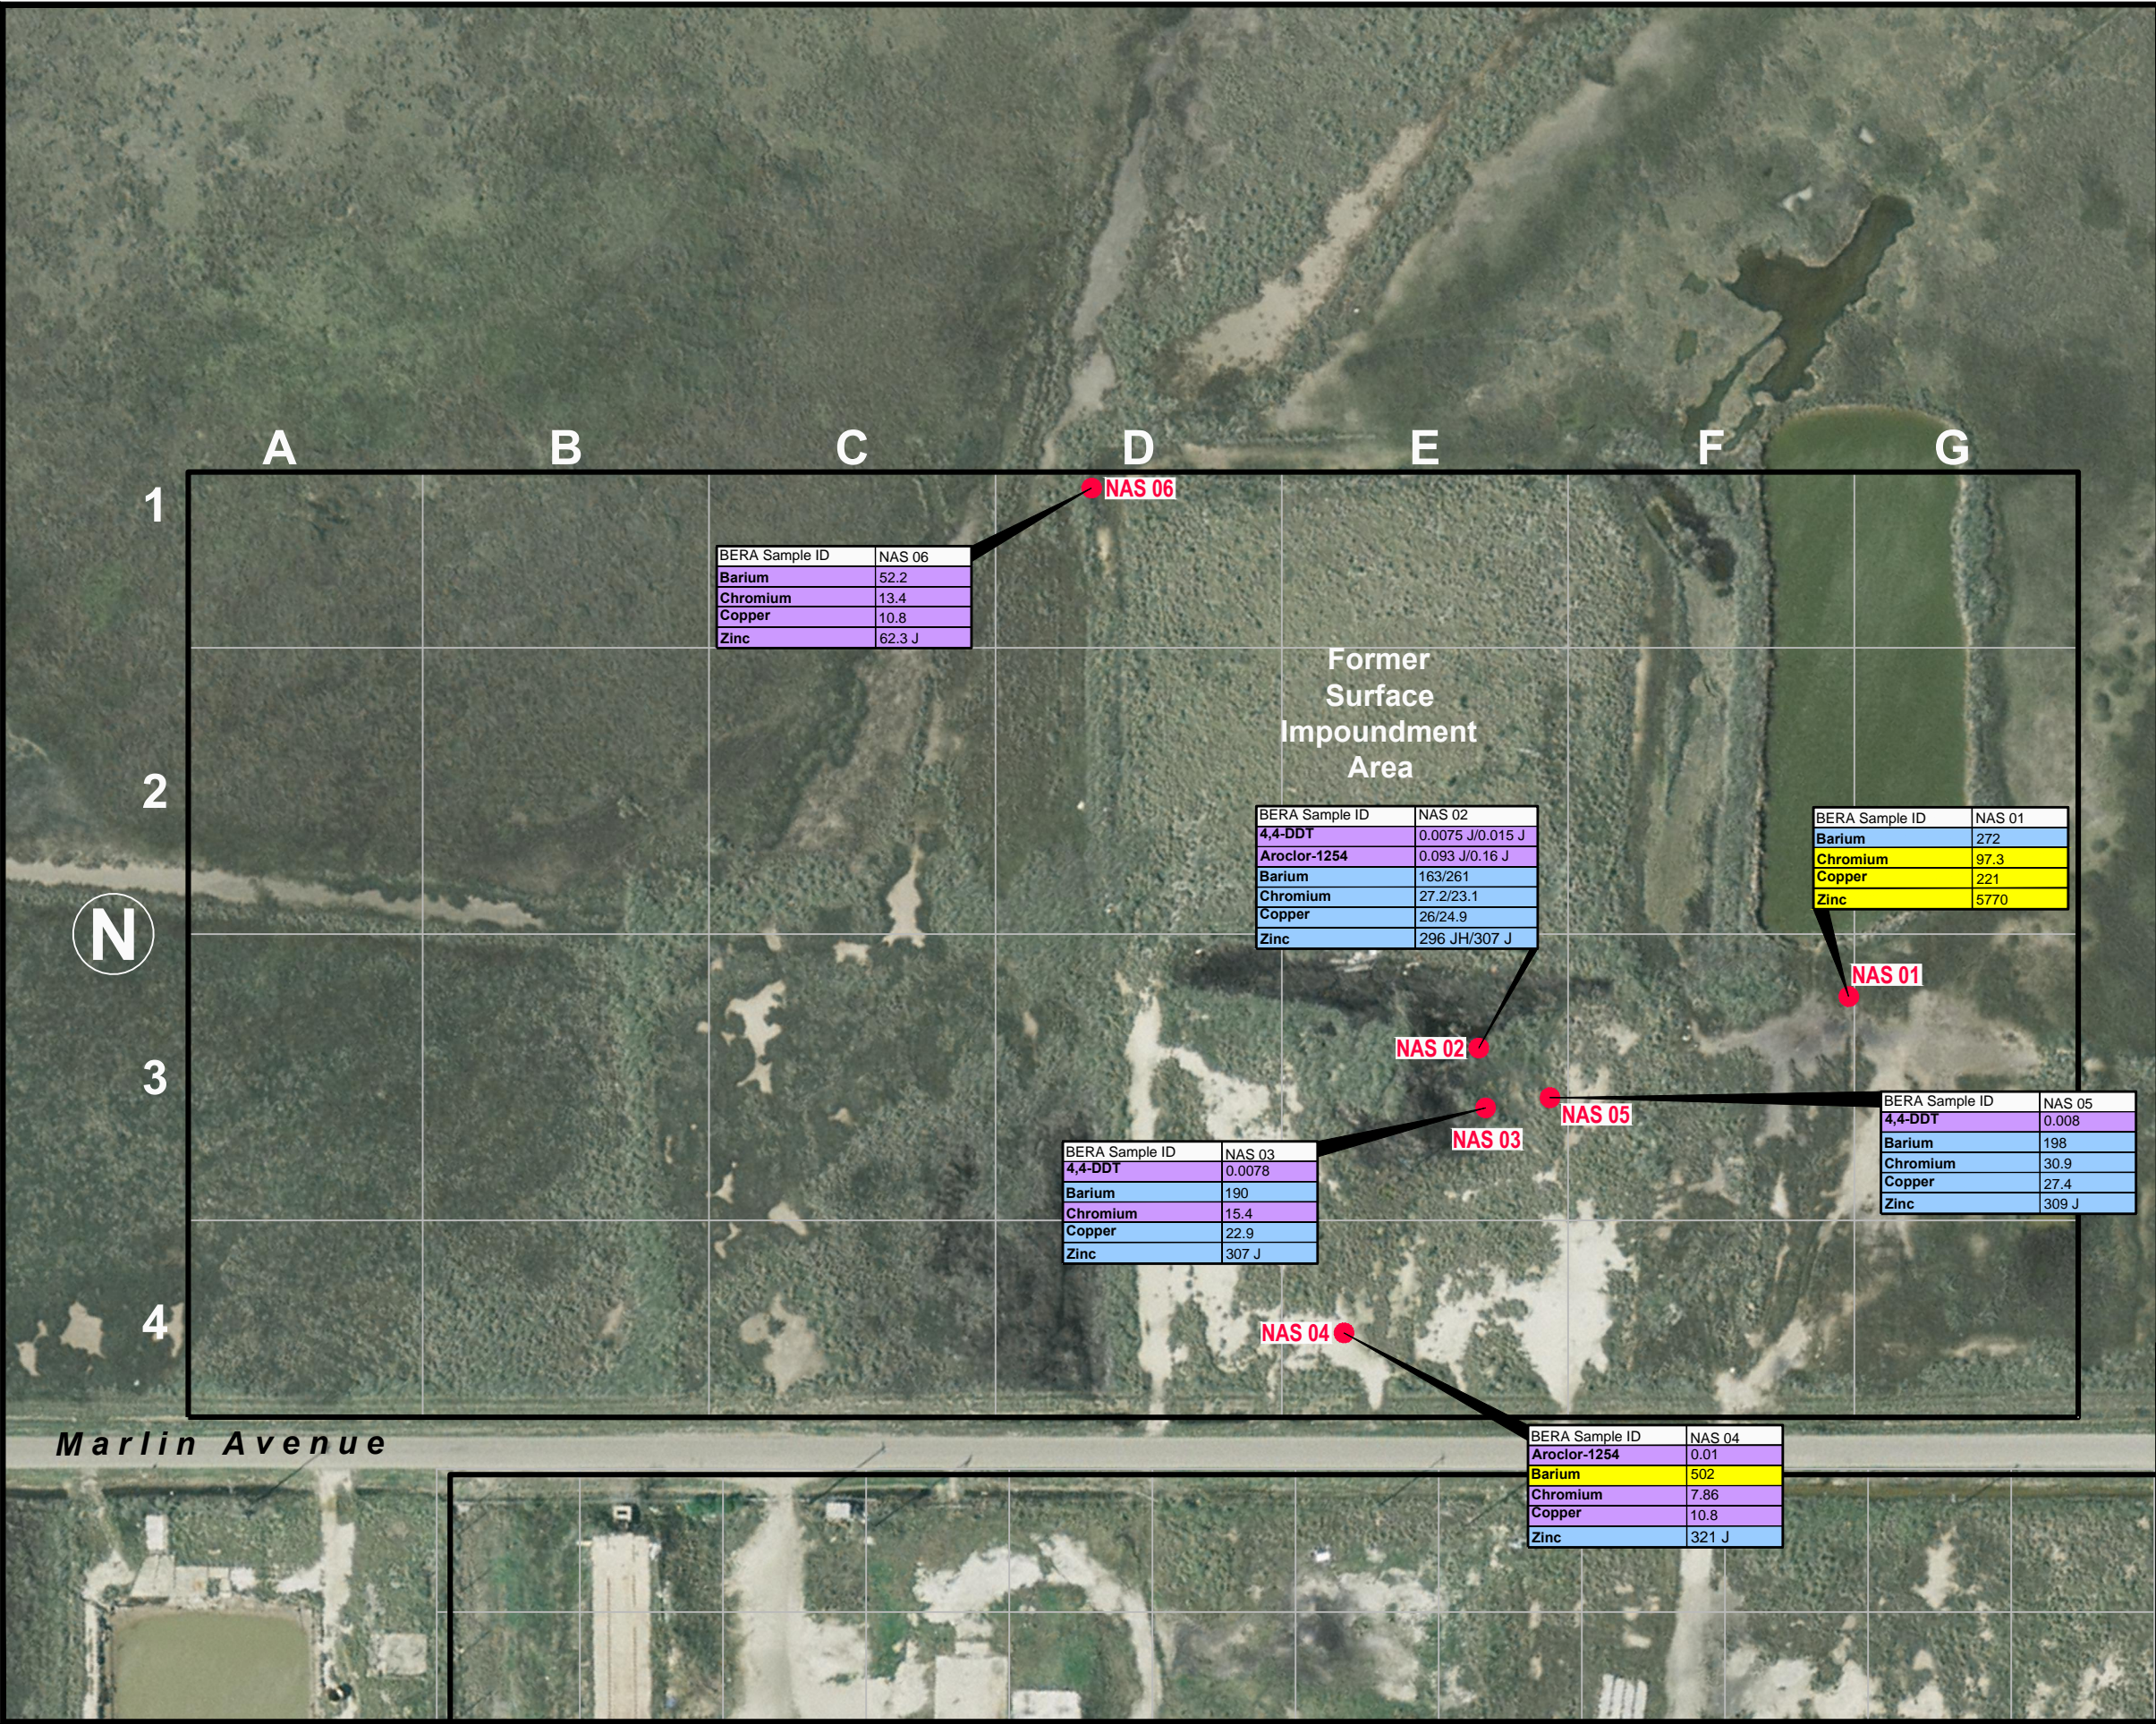
3

All Concentrations in mg/kg DW
